WASHINGTON STATE MAJOR LEAGUE BASEBALL
STADIUM PUBLIC FACILITIES DISTRICT

SAFECO FIELD LONG-TERM CAPITAL NEEDS ASSESSMENT

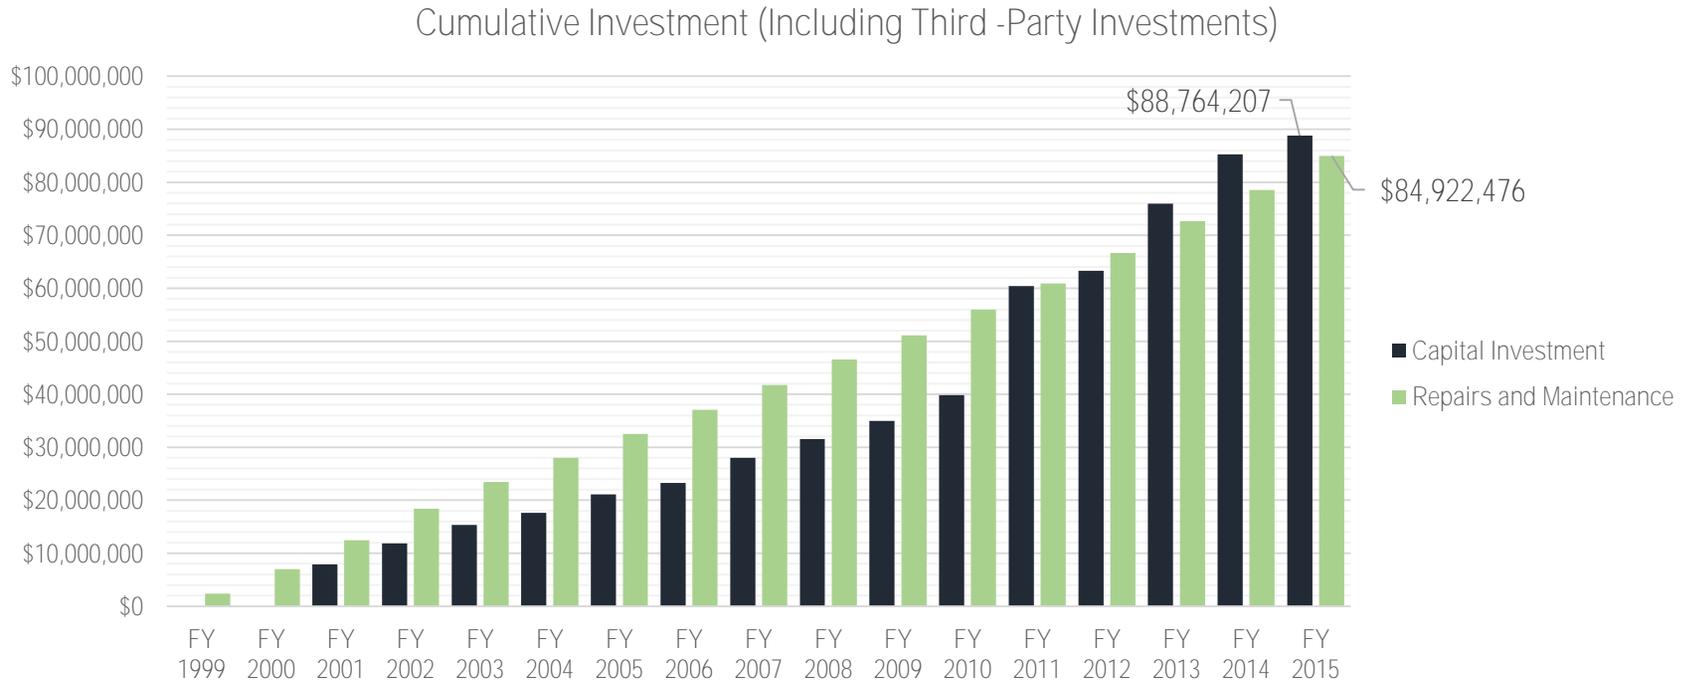
FIGURE 4.4: Cumulative Investment and Maintenance Comparison

Safeco Field has received \$89 million in capital investment through FY 2015. This figure is in addition to the \$85 million in repairs and maintenance costs incurred by the Mariners over the same timeframe. The comparative maintenance and capital investment graph is shown in Figure 4.4. Although repairs and maintenance costs are quite predictable, the capital investment bars are more variable between years due to the major investments described previously.

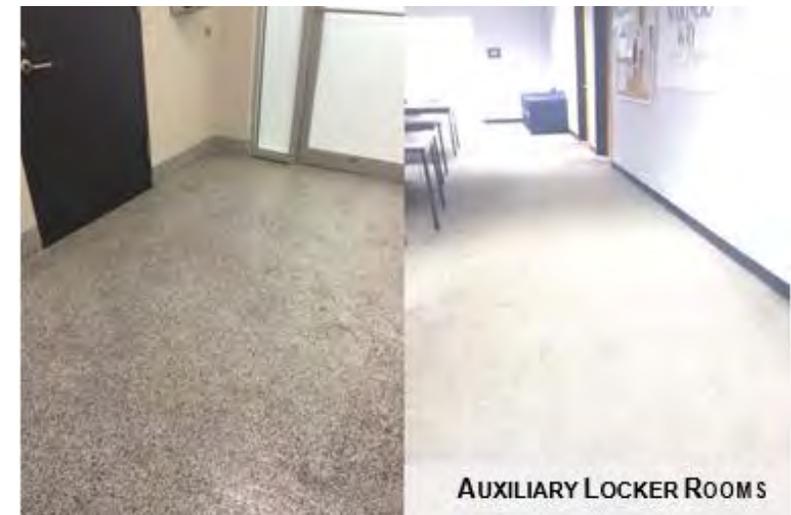
The umpire locker rooms are in good condition but are noticeably dated. The carpet is worn and doors are damaged because of repetitive use.

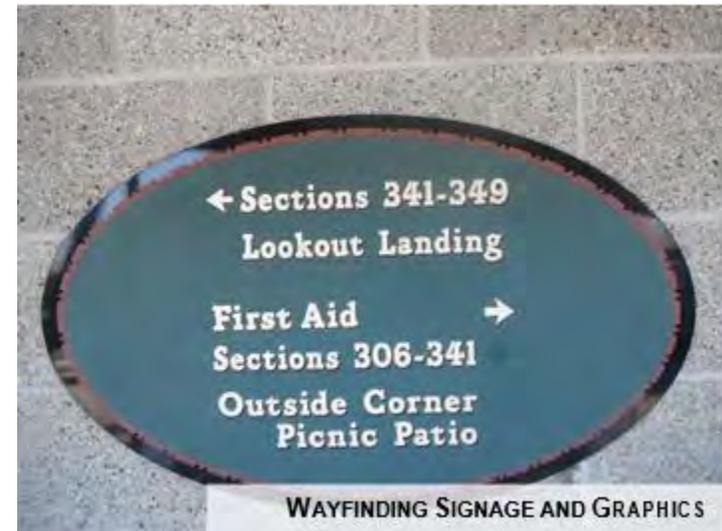
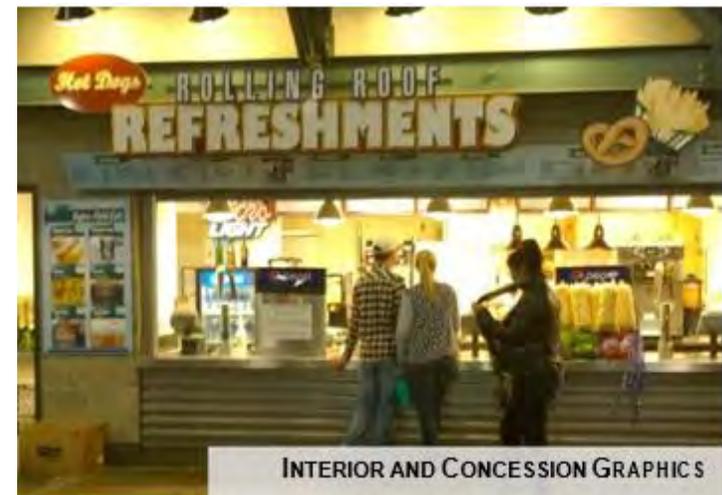
Exterior signage is original and showing wear. As such, it will need to be updated to reflect a more contemporary feel and look.

Program a modernization of the exterior branding and signage in conjunction with an update to the interior and concession graphics improvements.

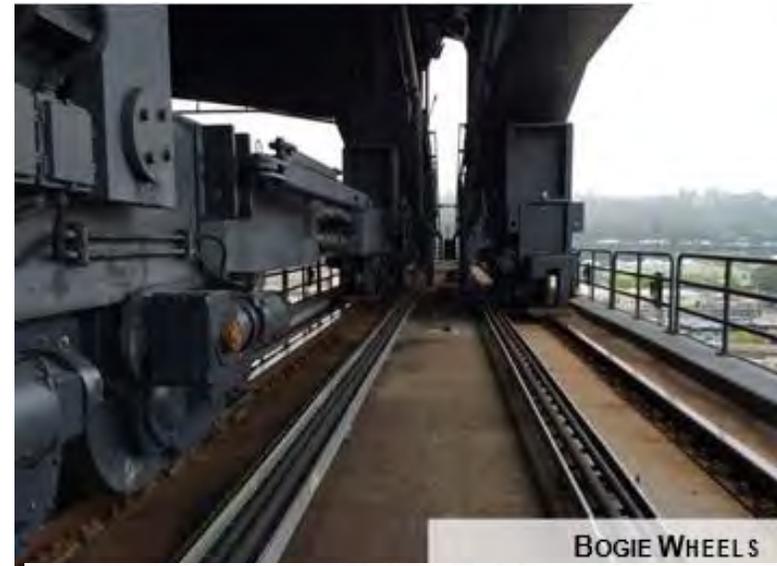
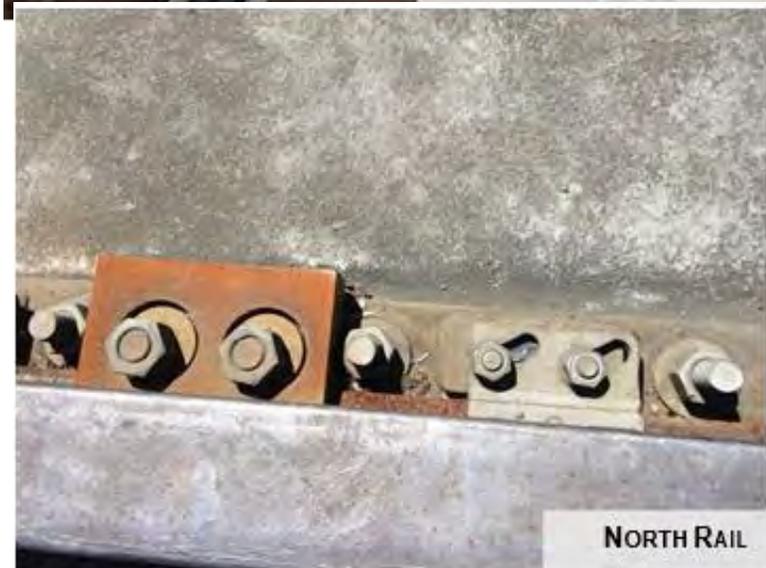
The programmable logic controller (“PLC”) is the “brains” of the retractable roof system. The system relies on primarily original hardware and software that were installed in 1999. The current suppliers who support the equipment will likely cease doing so at some point during the 20-year plan.

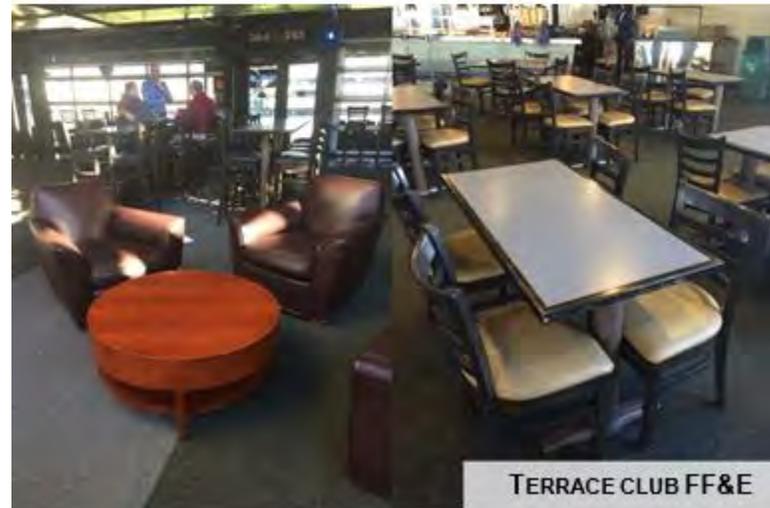
TERRACE CLUB FF&E

The Terrace Club contains over 4,600 seats on the 200 level. Each club seat holder is provided access to adjacent lounge areas on the first- and third-base sides of home plate. The adjacent lounge finishes, such as the flooring and woodwork, are very basic and have an industrial feel. Furniture is a mixture of high-top tables and other basic furniture.

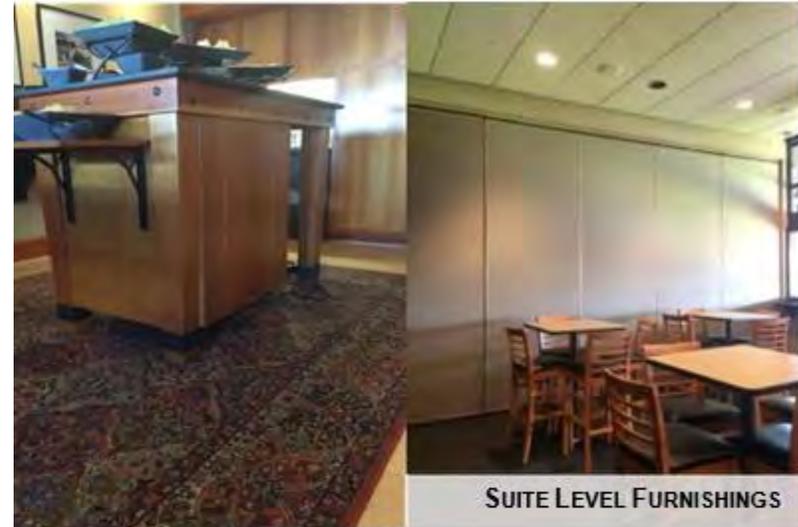
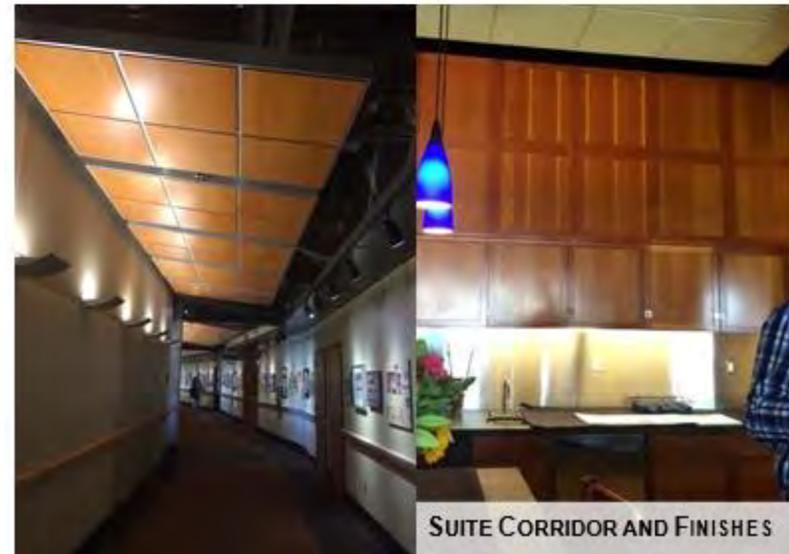
➤ **PR 3.0 & 3.1: SUITE LEVEL FINISHES & FF&E**

The suite level contains over 55 leasable suites, eight group suites, and a limited number of suites reserved for team and ownership use. The suites examined have mostly original furnishings that are dated from an aesthetic standpoint. The Consulting Team also observed that upholstery and operable partitions are worn in many places, while wood is chipped and scratched.

➤ **RECOMMENDATION: UPGRADE IMPROVEMENT**

Program a phased modernization of the suite level, including the suite corridor and individual units. The Consulting Team estimates that finishes and FF&E will last eight years, requiring refreshment twice during the 20-year plan.

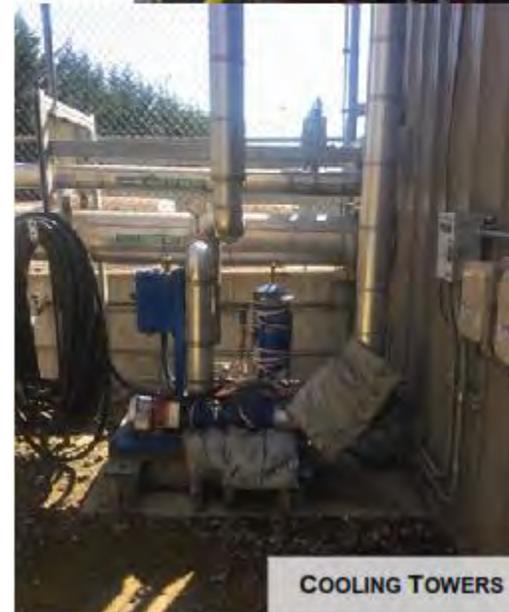
COOLING TOWERS

Three cooling towers produce condenser water for the water source heat pump loop. There are two 400-ton (nominal) and one 200-ton (nominal) towers. The towers have been upgraded recently and are in good operational condition. Most of the major equipment in the condenser water system is equipped with variable speed drives to optimize energy efficiency.

↘ RECOMMENDATION: UPGRADE IMPROVEMENT

Replace the cooling towers within the first 10 years of the plan in accordance with its recommended service life. A study of the plant operating capacity is recommended if future load is added to the system.

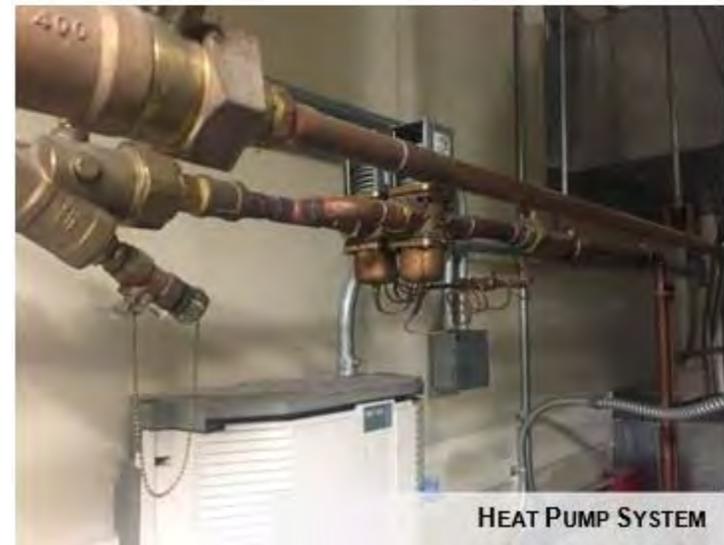
HEAT PUMP SYSTEM

Condenser water systems serve a combination of central station and distributed heat pumps. All heat pumps currently use R-22 as the refrigerant, which is being phased out, and facility personnel report concerns about refrigerant leaks. They also noted that the office areas can struggle to maintain temperature control. Generally, the heat pumps have performed well and are being replaced or re-built as they fail. However, distributed heat pumps are mostly original and have a recommended service life of 15 to 20 years.

➤ **RECOMMENDATION: NECESSARY IMPROVEMENT**

Program a phased replacement of heat pumps over the first half of the 20-year plan.
